NATIONAL BUREAU OF STANDARDS REPORT

AN INVESTIGATION ON THE FIRE SPREAD POTENTIAL OF PLASTIC PIPE INSTALLATIONS

10 342

I. A. Benjamin and W. J. Parker

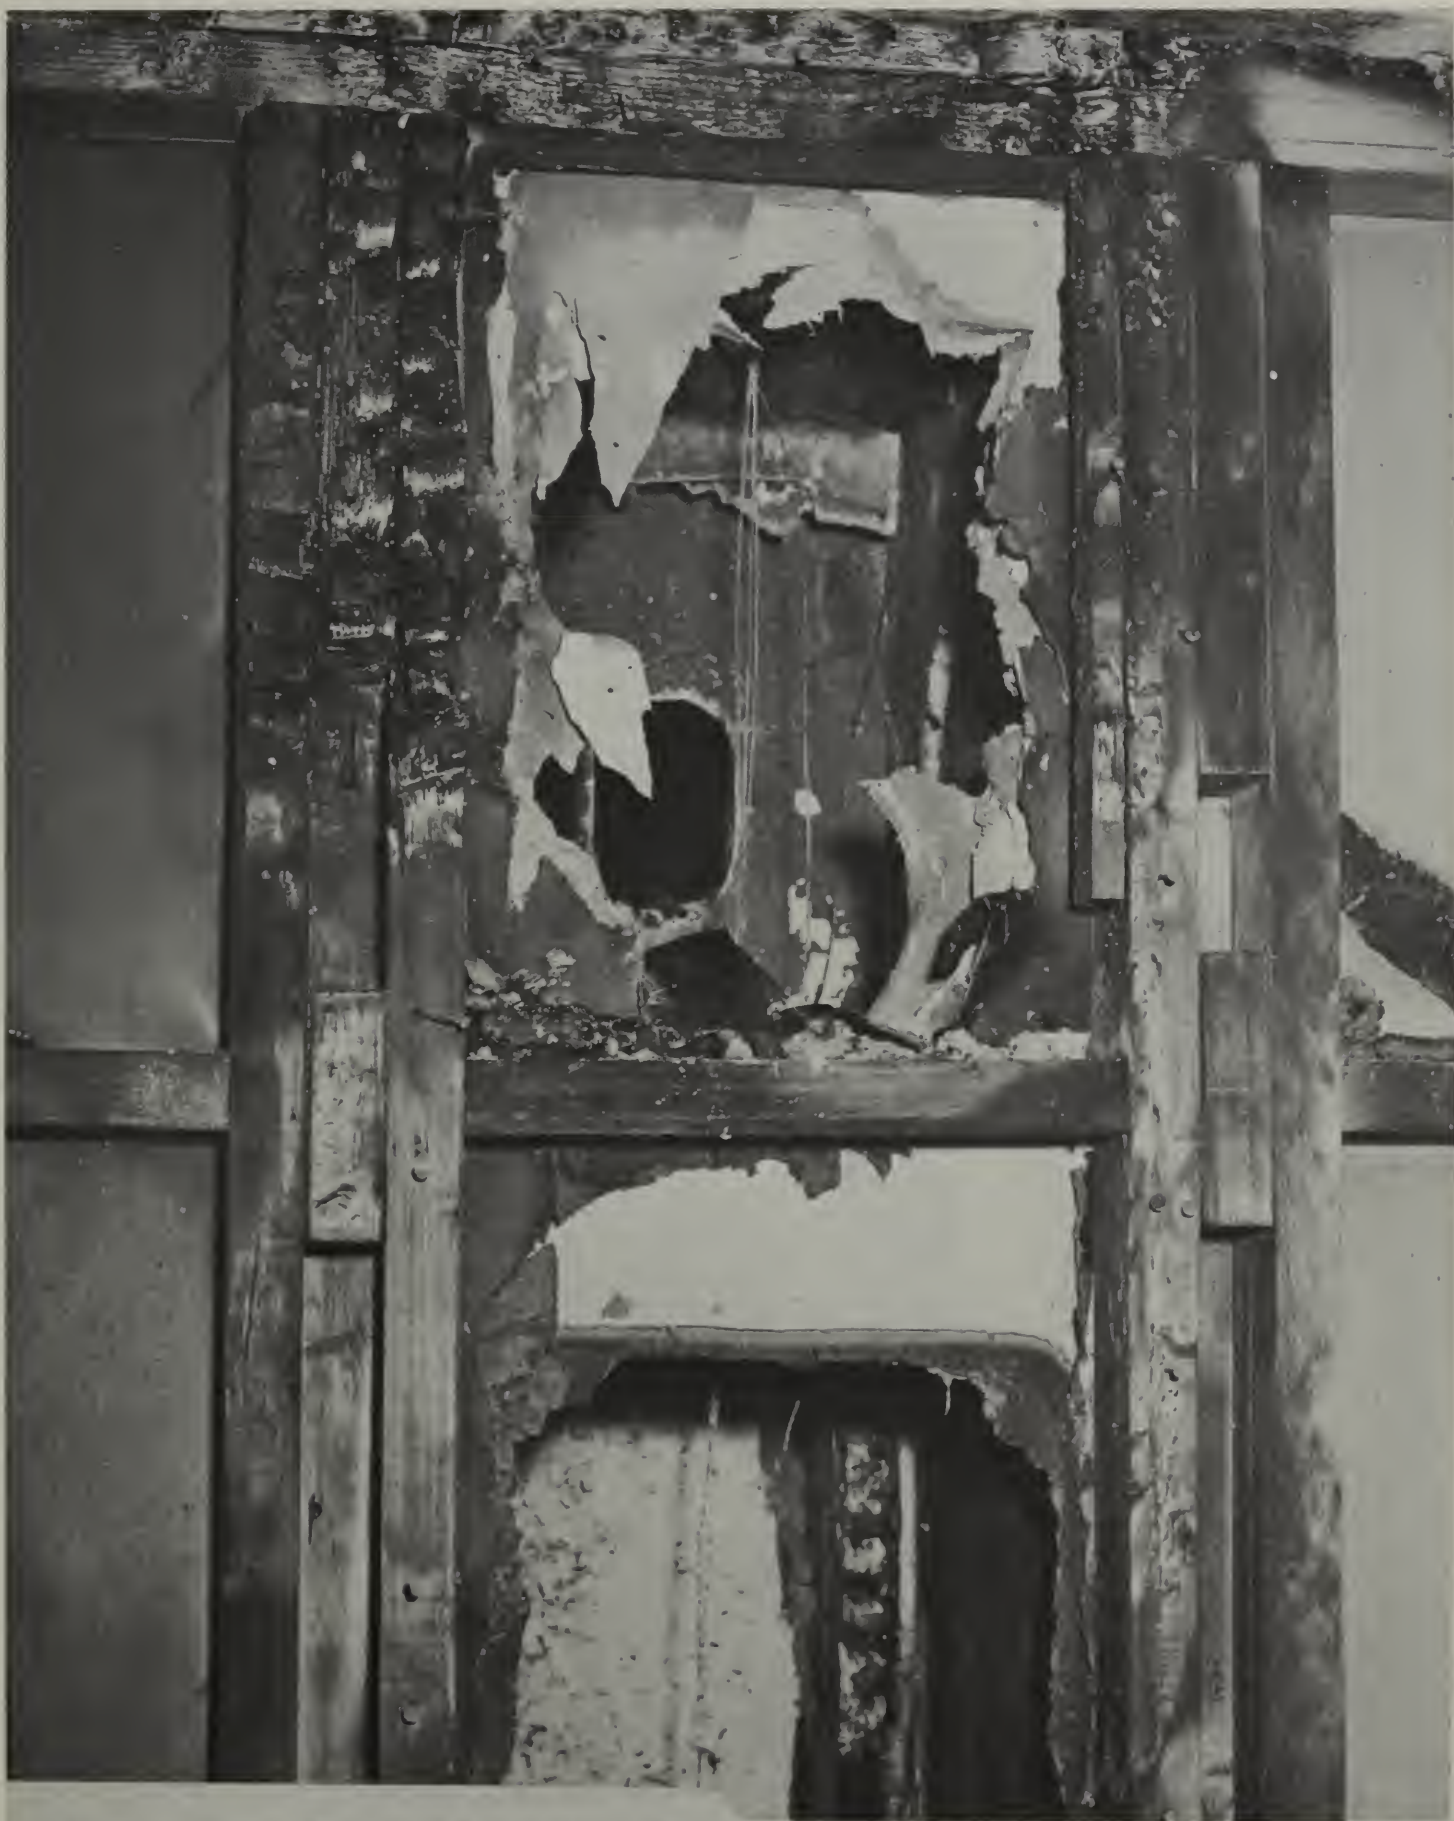
Fig. 30 Upper Part of Chase 7 After Test

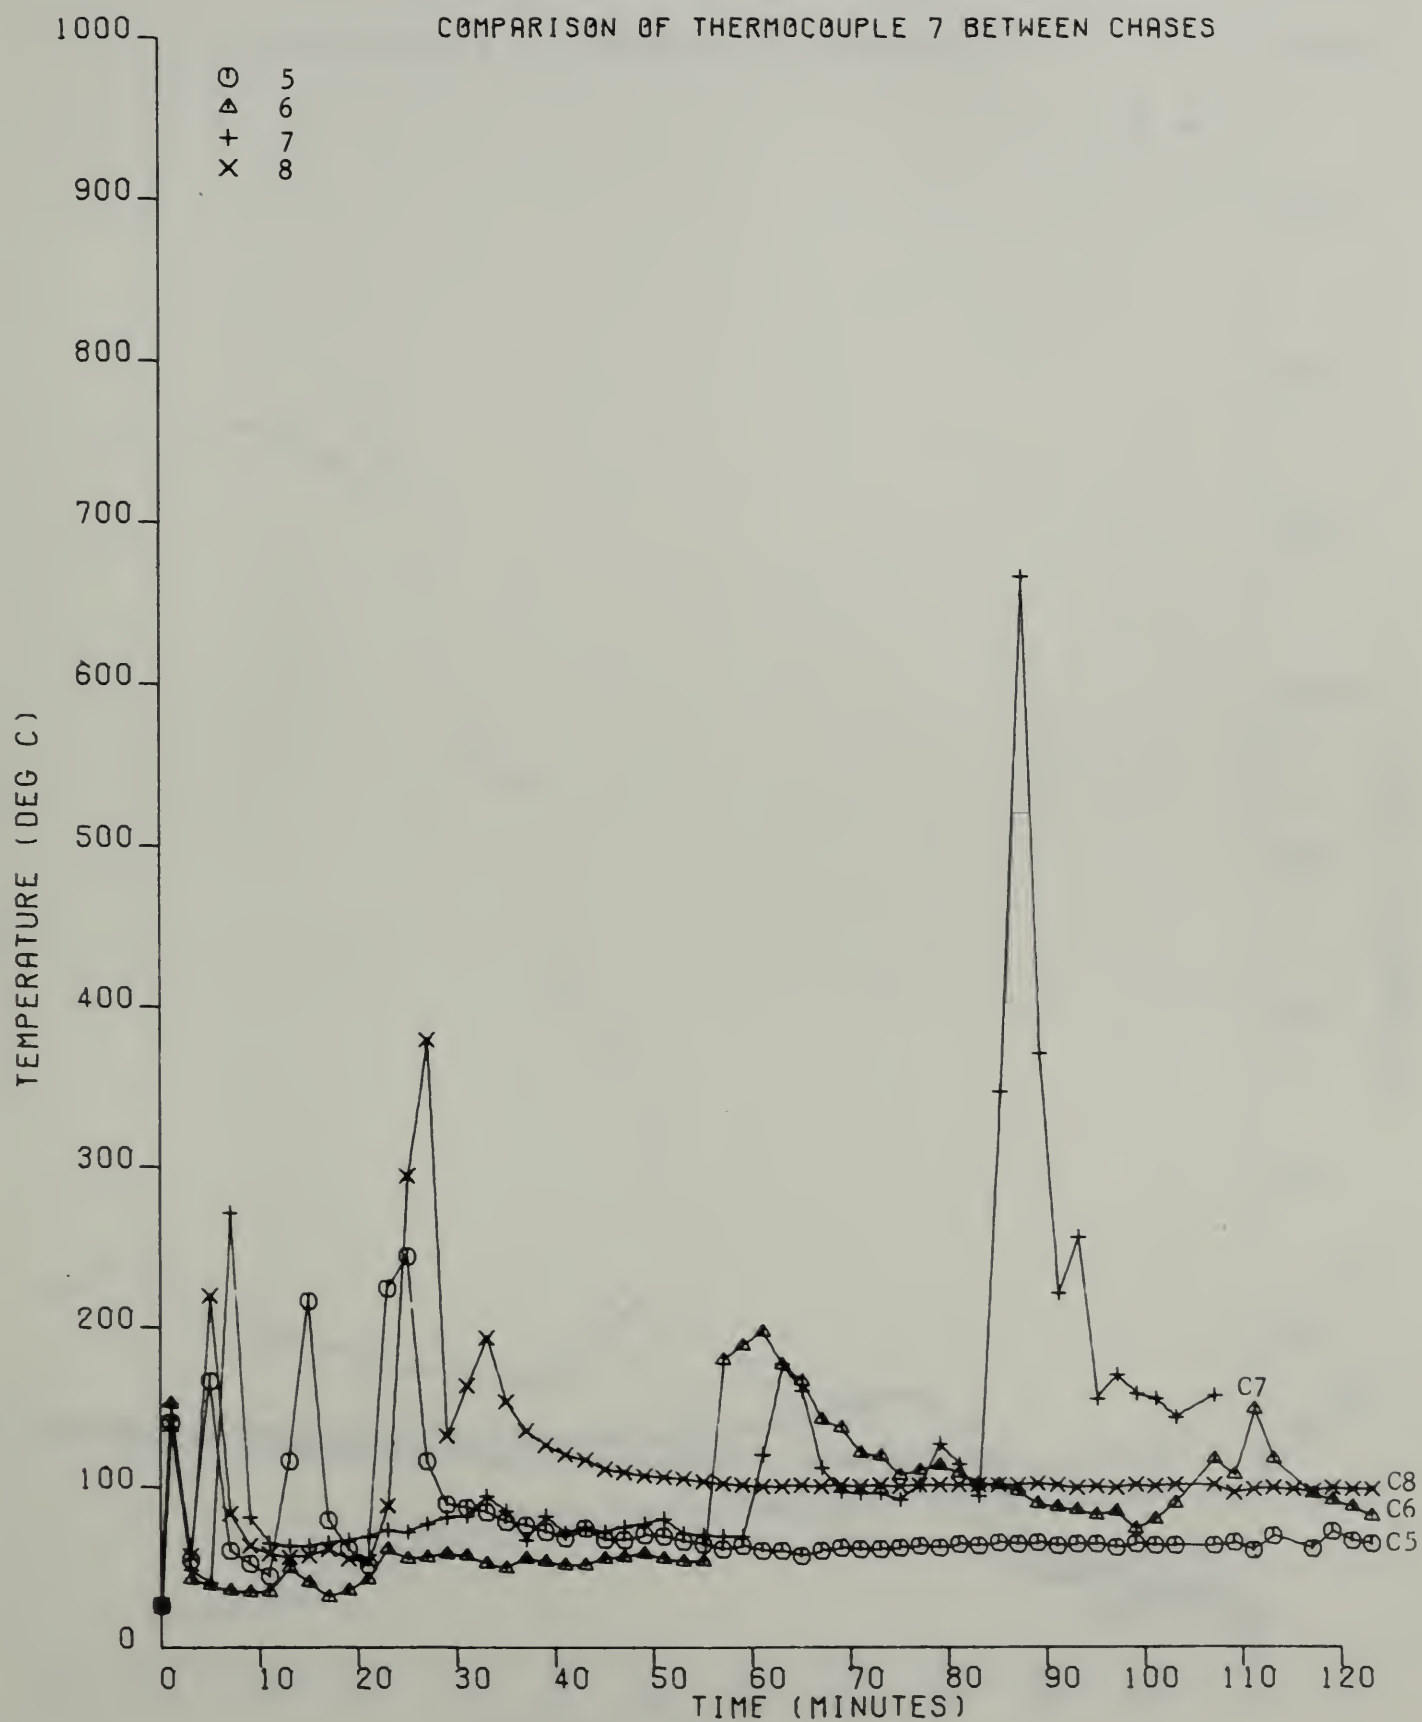
FIGURE 43

The temperature histories of all nine thermocouples in each chase are presented for the second pipe test in figures 33 through 40. A comparison of thermocouples 5,6,7 and 8 for each of the chases is shown in figures 41 through 44. In addition, the temperatures in the partition between the two middle chases is shown in figure 45.
